Manhole Inspection Summary

Manhole # S39YY_032MH

Insp Date: **12/15/06 1:10 PM**

Location Address: **803 33RD ST**

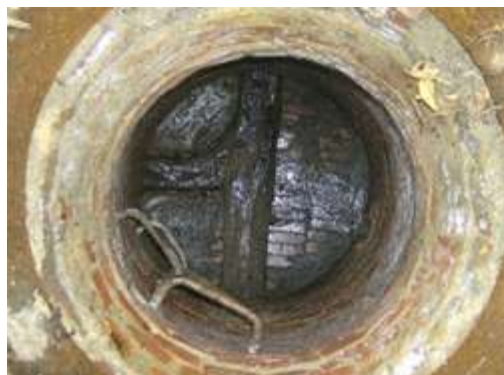
Top View

Corroded steps. Bench debris.

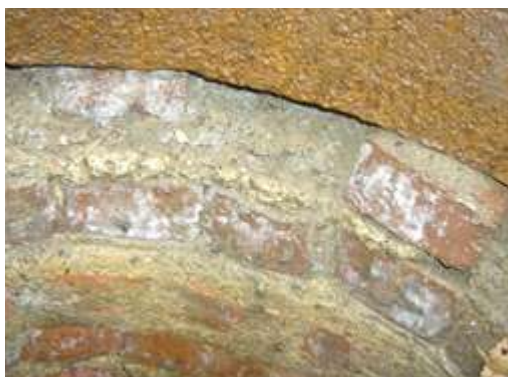
Defect

☒ **Leaks**

Condition: ☐ Sound ☐ Cracked ☐ Root Intrusion ☐ Loose Brick ☒ **Deteriorated**

Infiltration: ☐ None ☒ **Joint** ☐ Cracks ☒ **Mortar** ☐ Roots ☐ Wall

Frame leaks. Adjustment deterioration and infiltration.

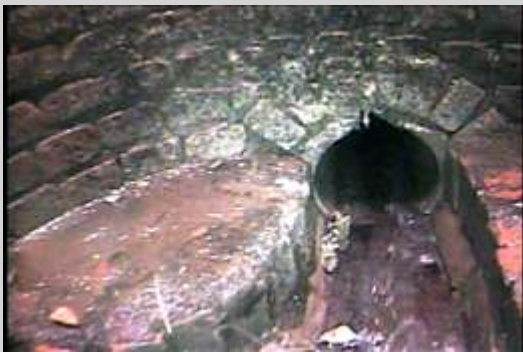
8 in. Circular Gravity Sewer Pipe Out @ 12 O'Clock

Barrel deterioration.

Infiltration: **None** Pipe Seal Cond: **Broken**

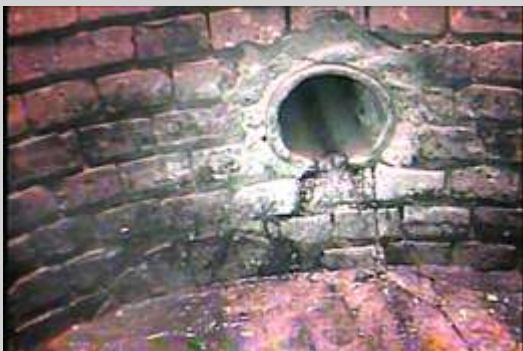
6 in. Circular Gravity Sewer Pipe In @ 3 O'Clock

Barrel deterioration.

Infiltration: **None** Pipe Seal Cond: **Roots**

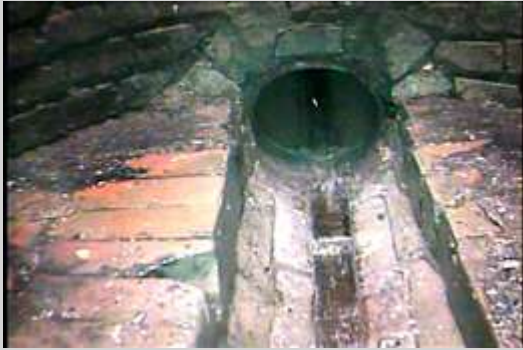
Pipe In @ 6 O'Clock

Bench and Barrel deterioration.

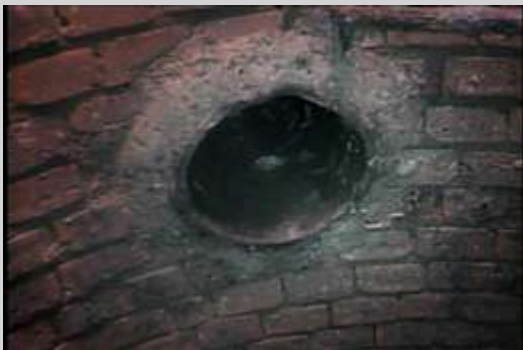
Pipe In @ 9 O'Clock

Barrel deterioration.

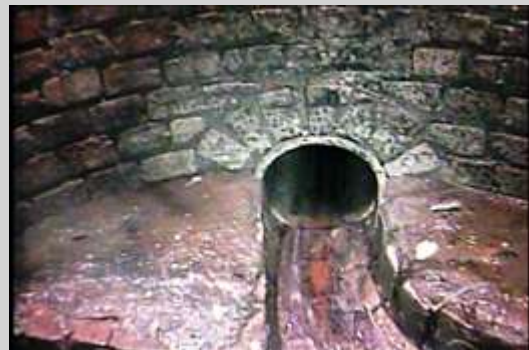
Drop In @ 9 O'Clock

Barrel deterioration and infiltration. Channel deterioration.
